Viewpoint Paper

Surface oxide effects on failure of polysilicon MEMS after cyclic and monotonic loading

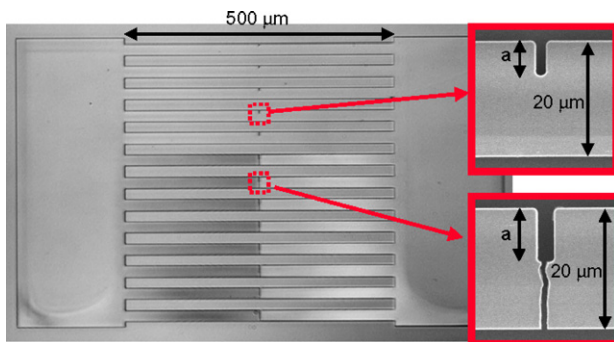
Figure 1. Optical micrograph of a clamped–clamped beam polysilicon device used to study fracture strength and static fatigue. Each of the 13 beams is fixed on both ends and contains a notch of depth, a . The insets are higher magnification SEM images showing two of the 13 notches after release.

beams broke even though the stresses in some of the beams must have been extremely close to the fracture strength. This essentially confirms the absence of stress corrosion in notched polysilicon specimens subjected to constant loads.

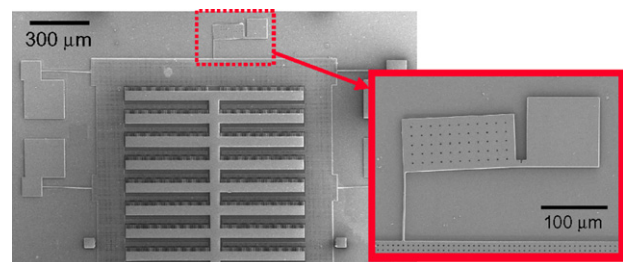
After release, our polysilicon devices exhibited surface oxides with thicknesses of ~ 3 nm, as determined by X-ray photoelectron spectroscopy, typical of “native oxide” growth on silicon surfaces in air. To investigate the effects of thicker surface oxides, devices usually used for fatigue testing [3,5], shown in Figure 2, were used. Since compressive stresses are generated during polysilicon oxidation [13], the devices in Figure 1 were not suitable. However, the devices in Figure 2 contained large comb-drive actuators which could be pushed downward and then adhered to the substrate using drops of water, creating constant tensile stresses at the notch roots of the specimens shown in the inset to Figure 2. The $6\ \mu\text{m}$ thick specimens were deflected to achieve a tensile stress of $\sim 3.2\ \text{GPa}$ at the notch root, as determined by FEA, ignoring any local stresses created by oxidation. For each oxide thickness to be studied, 4–6 polysilicon devices were oxidized in air at $920\ ^\circ\text{C}$ to achieve oxide thicknesses of 45, 70, 82 and $140\ \text{nm}$, as measured by spectrophotometry on the single crystal silicon substrates. After 200 h in 90% relative humidity air, approximately half of all the specimens had broken. Presumably, moisture-assisted stress corrosion of the surface thermal oxide resulted in crack initiation and growth within the oxide layer, sufficient to cause catastrophic crack propagation through the polysilicon specimen. Using the standard relation for fracture toughness $K_{Ic} = k\sigma_{crit}(\pi a)^{1/2}$, where σ_{crit} is the stress at failure, a is the size of the crack-initiating flaw, and k is a constant equal to 0.71 for a semi-circular flaw [14], and using $K_{Ic} = 1.0\ \text{MPa}\cdot\text{m}^{1/2}$ [15], the critical flaw size is $\sim 60\ \text{nm}$. This is roughly consistent with the oxide thicknesses used here.

Figure 2. SEM image of an oxidized polysilicon device, deflected such that the maximum stress at the notch root is 90% of the average monotonic strength. The inset shows a higher magnification view of the specimen, showing the notch.

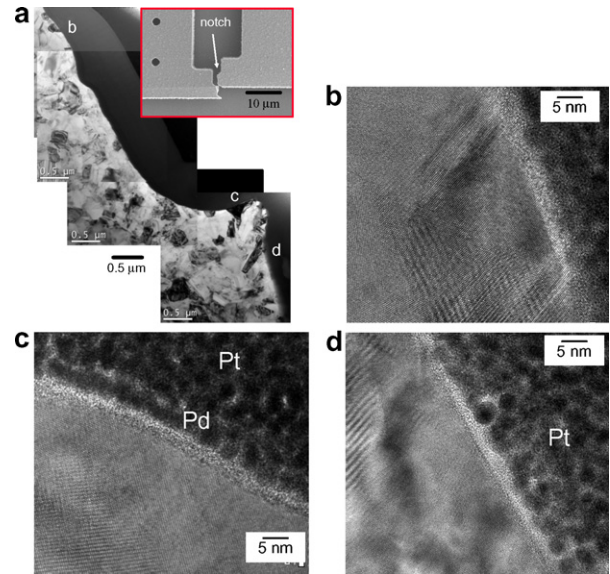
A low magnification bright field TEM image taken in a high-resolution TEM is presented in Figure 4a, and high-resolution TEM images of the three locations noted in Figure 4a are shown in Figure 4b–d. In all three areas – the area away from the notch root that experienced very low applied cyclic stress (Fig. 4b), the area at the notch root next to the fracture which experienced the highest cyclic stresses (Fig. 4c) and the area of the fracture surface that experienced no applied stresses (Fig. 4d) – the surface oxide is seen as a bright amorphous layer on top of the crystalline polysilicon. Its

Figure 4. (a) Low magnification TEM image of the notch root region of a polysilicon fatigue specimen after fracture (3×10^7 cycles), shown in the SEM image in the inset. (b–d) High-resolution TEM images of the three areas noted in (a), (b) away from the notch root, (c) at the notch root, and (d) along the fracture surface.

thickness is a constant ~ 3 nm. This thickness of the surface oxide was confirmed by X-ray energy dispersive spectroscopy (XEDS) line scans in the TEM. Clearly, no oxide growth occurred due to the high cyclic stresses.

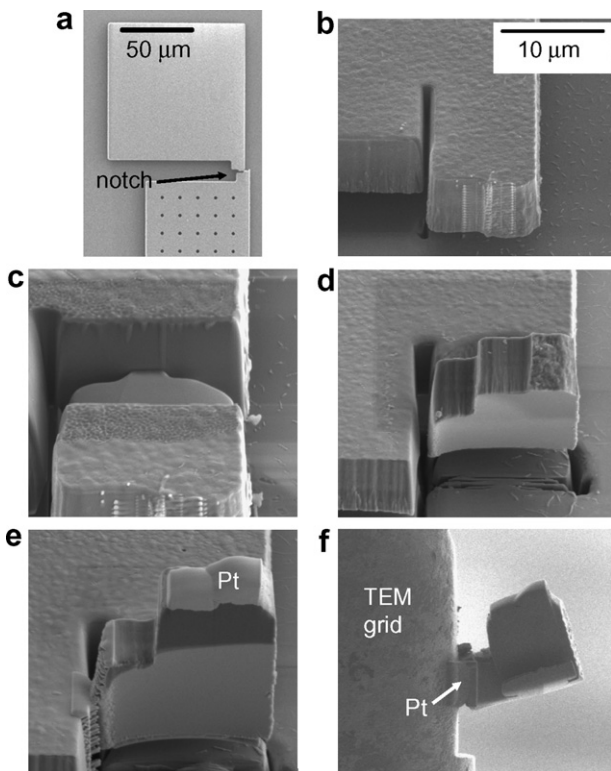
Figure 3. SEM images showing TEM sample preparation of a polysilicon MEMS device near the fatigue fracture. (a) The device showing fatigue fracture at the notch root. (b–e) Tilting and removal of the portion of the device adjacent to the fatigue fracture using FIB machining. (f) The removed portion of the device attached to a TEM grid. See text for more details.

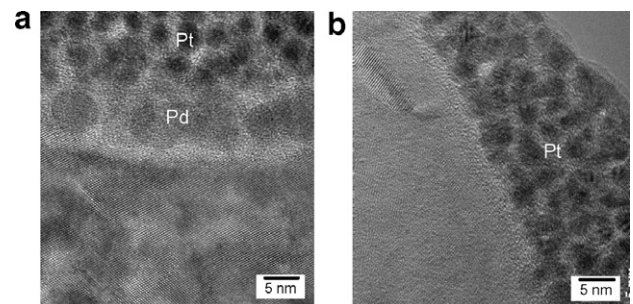
The same TEM investigation was repeated with a fracture specimen that failed after 6×10^6 cycles under the same stress conditions. High-resolution TEM images of the high stress area at the notch root and the newly formed fracture surface are shown in Figure 5a and b, respectively. The observed oxide layers are essentially indistinguishable from those in Figure 4. In Figure 4b–d and Figure 5a and b, the contrast seen beyond the oxide layer is due to Pt deposited during FIB machining. In Figure 4c and Figure 5a, a separate layer next to the oxide can be seen which corresponds to the thin Pd layer that was sputtered onto the devices before fatigue testing, to ensure sufficient electrical conductivity for the electrostatic actuation [3].

Figure 5. High-resolution TEM images of a polysilicon fatigue specimen after fracture (6×10^6 cycles): (a) at the notch root and (b) along the fracture surface.
