Nonlinear Finite Element Analysis of Critical Gusset Plates in the I-35W Bridge in Minnesota

Abstract: Reported evidence suggests that failure of gusset plates initiated the collapse of the I-35W Bridge in Minneapolis, Minnesota. The particular gusset plates were at a panel point designated as U10. Therefore, an analytical investigation was conducted on the condition of the U10 gusset plates at the time of bridge collapse. The forces delivered to panel point U10 were reproduced using available information of the bridge. These forces were introduced to detailed nonlinear, three-dimensional finite element models to calculate stress and strain states of the gusset plates. The results indicate that substantial portions of the U10 gusset plates were yielded at the time of collapse, confirming earlier findings from federal and state investigations. Weight increase due to past deck reconstruction and construction material and equipment staged on the day of collapse, along with insufficient thickness of the gusset plate, were identified as the main contributing factors to the substantial yielding. The results also suggest that the interaction of compression and shear played an important r

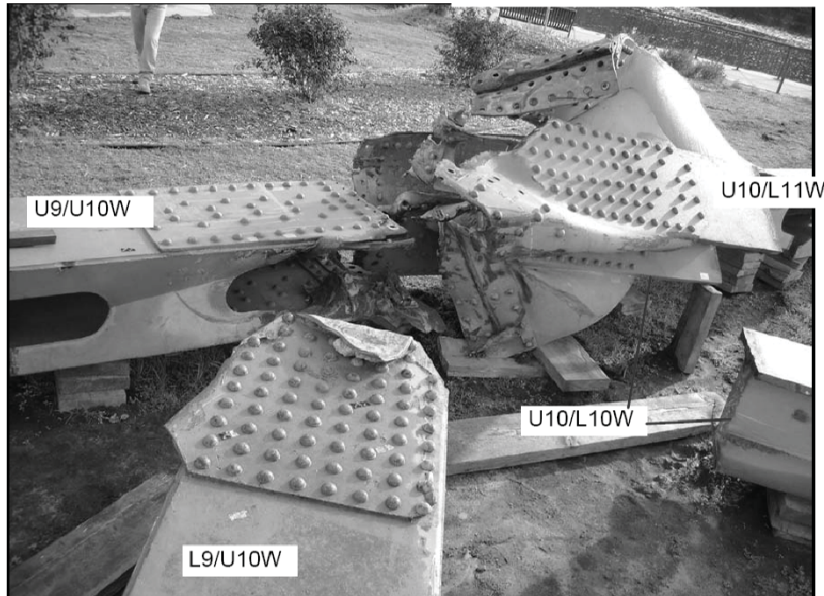
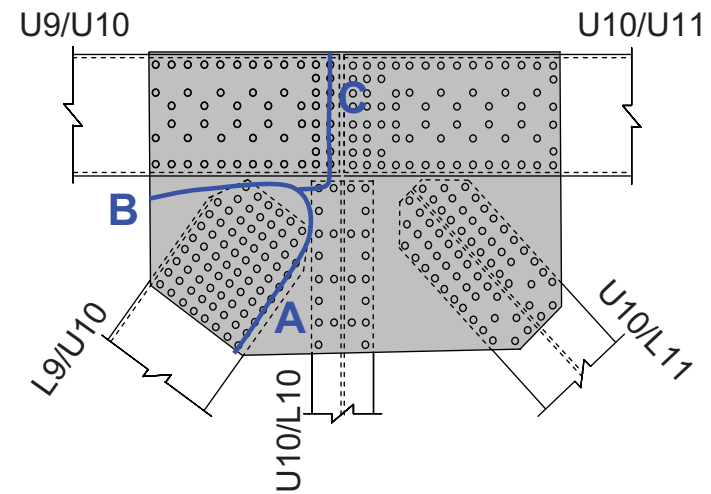
Fig. 3

Fig. 3(a) shows a photograph of panel point U10W taken after the collapse (NTSB 2008c), while Fig. 3(b) illustrates the three primary fractures seen in Fig. 3(a) and that were commonly observed in all four U10W and U10E gusset plates:

(A) Diagonal fracture along rivet holes connecting the gusset plate to the compression diagonal L9/U10. The fracture occurred along the perimeter holes of the rivet group adjacent to U10/L10.

(B) Horizontal fracture below the lower edge of upper chord U9/U10.

(C) Vertical fracture near the separation between the upper chords U9/U10 and U10/U11.

- Fig. 3.** Panel point U10 after collapse: (a) photograph of U10W (from NTSB 2008c); and (b) reported locations of fracture.
- Fig. 4.** Influence lines of truss forces in L9/U10 and U10/L11.

The primary objective of the local model analysis was to examine the stress and strain condition that may lead to the failure shown in Fig. 3. Therefore, the rivet connection was explicitly modeled only between the compression diagonal L9/U10 and the gusset plates. Unlike the other four truss members which were merged to the gusset plate, the diagonal L9/U10 was modeled as an independent element. Force transfer by contact of two elements was permitted only in the direction normal to the surface (In other words, friction was neglected). Rivets were modeled as rigid cylindrical shells interacting with the periphery of the rivet holes. A uniform pressure of 56.5 MPa was applied at both sides of the riveted joint within an annular region of 7.6 mm from the edge of holes to produce a pre-tension of 44.5 kN. This pre-tension is equivalent to the minimum bolt-pretension specified by the Research Council on Structural Connections (RCSC 2004). The pressure was needed to prevent separation between the diagonal and the gusset plates during analysis, and it did not lead to a frictional resistance contribution to the connection because friction between the plates was neglected.

The above analysis results, combined with the fracture study by the NTSB (2008a), suggest that failure of gusset plate U10 initiated either along the perimeter of the compression diagonal (fracture (A) in Fig. 3(b)) or along the critical shear plane below the upper chords (fracture (B)). The location of yielding suggests that interaction of shear force and compression may have influenced the failure. The interaction is not expected to lead to potentially dangerous conditions of properly sized gusset plates. However, it is worthwhile to consider the compression-shear interaction for the undersized U10 gusset plates. To this end the local model analysis was repeated for a modified gusset plate connection shown in Fig. 8(b) that replaces the top chord U9/U10 and vertical U10/L10 by fixed edge supports. This connection is a compression connection, unlike the U10 connection which is subjected to combined shear and compression, but resembling the specimens studied by Yam and Cheng (1993). However, due to the short unsupported edges of the gusset plate, buckling should not be a concern for this compression connection.

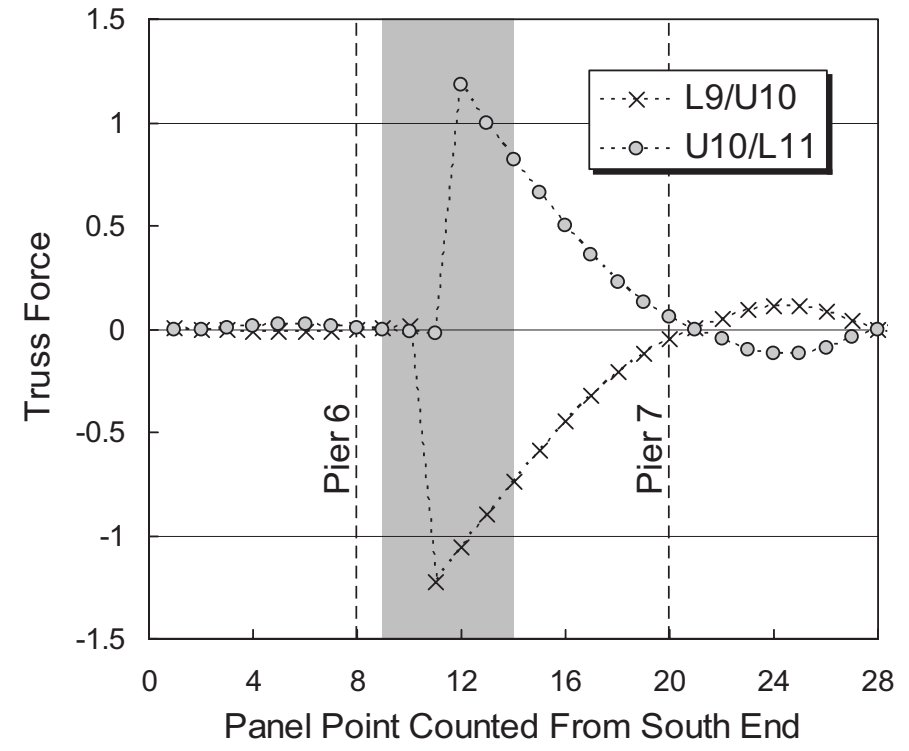
Fig. 4 shows the plot of influence lines for the truss forces (positive in tension) in the compression diagonal L9/U10 and tension diagonal U10/L11. The influence lines indicate that loads applied on the center span produces compression in L9/U10 and tension in U10/L11, and that loads placed near U10 produce a very large response. Therefore, the temporary construction loads (CL), which were placed in the shaded region of Fig. 4, may have significantly affected the forces imposed on the U10 gusset plate.

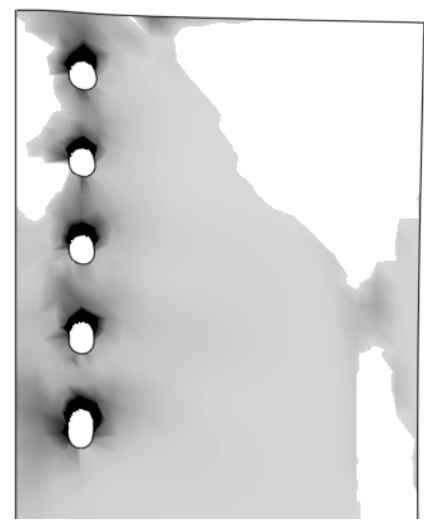
Fig. 5

- Fig. 5.** Tension gusset plate connection: (a) photograph of plate after testing (Hardash and Bjorhovde 1985, with permission from AISC); (b) finite element models; and (c) deformation and Mises stress distribution.

The first validation used a bolted tension connection reported by and designated as Specimen 28 by Hardash and Bjorhovde (1985). This connection exhibited a long yield plateau leading to a tensile strength of 560 kN, and ultimately failed by block shear failure of the gusset plate. Fig. 5(a) shows the gusset plate after testing, where tensile fracture across the last row of bolts and elongation of bolt holes is visible. The finite element model of the gusset plate is shown in Fig. 5(b) as the global model. Considering symmetry, only one half of the gusset plate was modeled. All nodes along the left edge of the model were restrained against translation in two transverse (X and Z) directions. All nodes at the bottom edge of the plate were restrained against translation in all three (X, Y, and Z) directions. The bolts were modeled as rigid cylindrical shells. The rigid shells were displaced equally in the upward (positive Y) direction to deliver load to the gusset plate. The remaining five degrees-of-freedom of the rigid shells were restrained.

A comparison study of element types and mesh refinement led to the conclusion that the overall behavior of these connections may be modeled appropriately by using C3D8 elements and 16 elements surrounding the bolt holes. For example, Fig. 6(a) compares the loading curve obtained from using different solid elements, designated as C3D8 (linear isoparametric brick element), C3D8R (linear brick element with reduced integration), and C3D4 (linear isoparametric tetrahedral element) in the ABAQUS element library. All analyses used a similar meshing strategy with 16 nodes surrounding each bolt hole. The models using C3D8 or C3D8R achieved the measured strength of 560 kN at 10 mm displacement (after the bolts contacted the hole perimeter), and continued to develop larger strength. The strength degradation observed in the experiment was influenced by fracture propagation between the last row of bolts. Therefore, the discrepancy between the experiment and analysis may be attributed to absence of a fracture model in the analysis. The model using C3D4 exceeded the measured strength at a much smaller deformation of 4 mm, and was therefore judged as less appropriate than the other two models. Fig. 5(c) shows the deformation of the gusset plate and the Mises stress distribution when the bolts were displaced by 10 mm. Overall, the computed deformation and stress distributions and the photograph of the test specimen in Fig. 5(a) share several important similarities: Very high stresses were computed near the bearing side of the bolt holes, and also across the last row of bolt holes where fracture was observed in the test. In addition, deformation of the plate was supplied by bolt hole elongation, most notably at the last bolt hole.

In order to examine the critical stress and strain condition that led to fracture of the gusset plate, a densely meshed model representing the region surrounding the last row of bolt hole, shown in Fig. 5(b) as the submodel, was analyzed using the submodeling technique (Simulia 2008). The displacement field obtained from the global model was used as boundary conditions

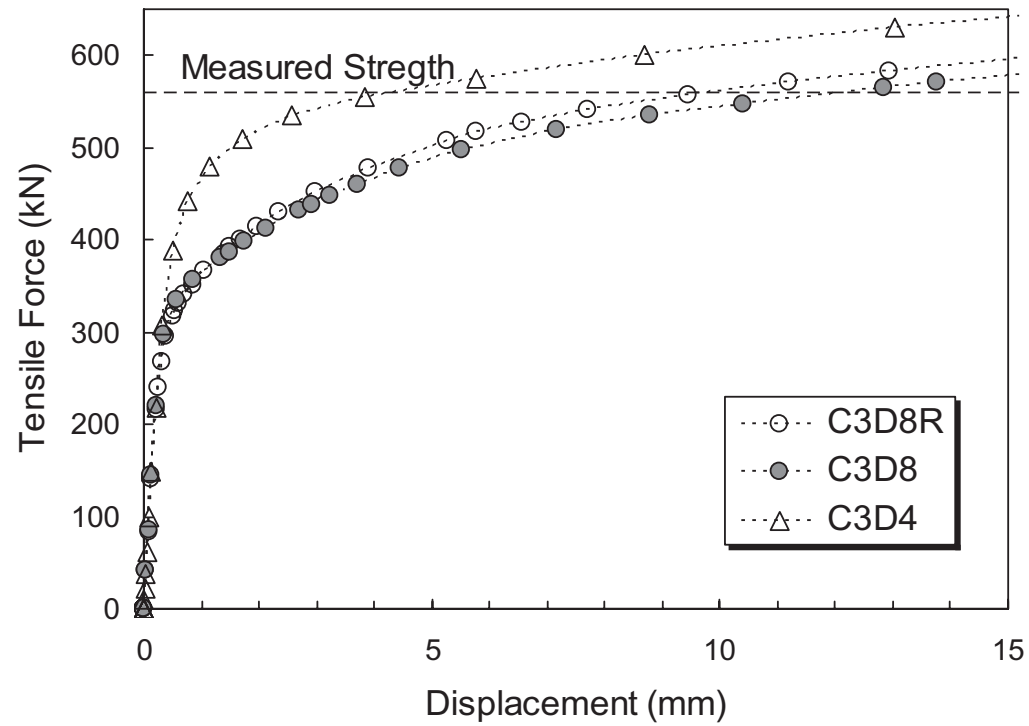
Fig. 6(a)

- Fig. 6.** Verification for tension gusset plate connection: (a) loading curve; (b) normal stress distribution; and (c) PEEQ distribution.
- Fig. 7.** Verification for compression gusset plate connection: (a) finite element model before and after deformation; and (b) load versus out-of-plane displacement.

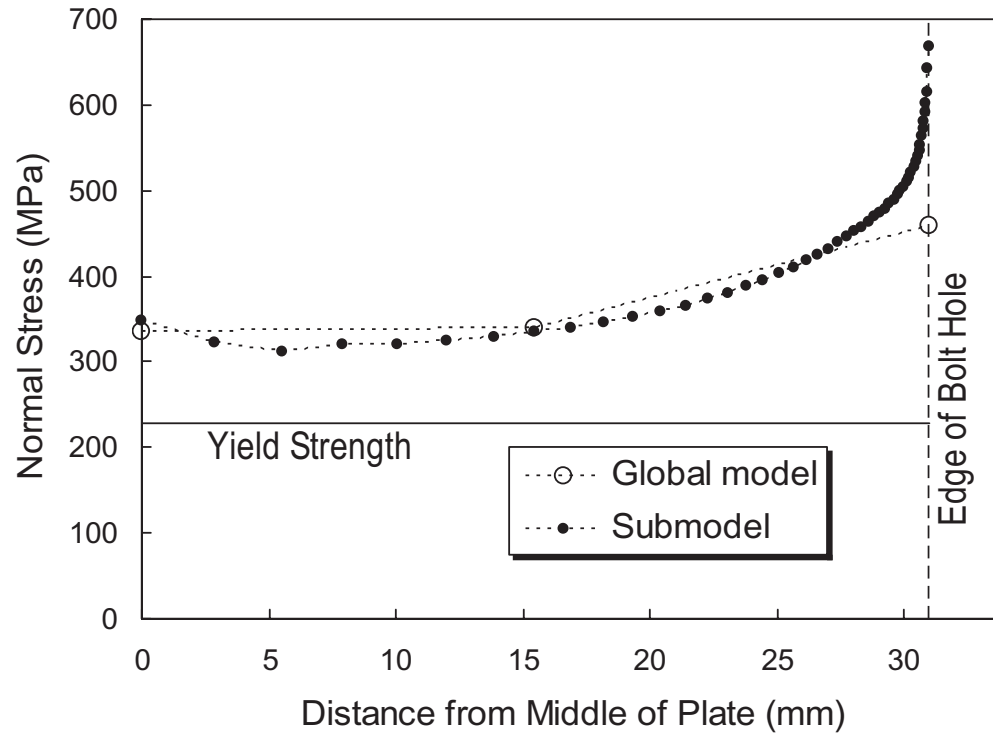
Fig. 6 (b)

for the submodel analysis. Fig. 6(b) and (c) plot the distribution of normal stress, σ_{YY} , and equivalent plastic strain, PEEQ, respectively, along the sampling line connecting the two bolt holes. The abscissa indicates the distance measured from the middle of the plate. The figure compares the results from the global model and submodel when the bolts were displaced by 10 mm (the loading stage when the measured strength was reached). The figures indicate that the yield strength (229 MPa) was exceeded along the entire length between the last row of bolts. Both σ_{YY} and PEEQ were largest at the edge of the bolt hole. The major difference between the global model and submodel occurs only near the edge of the bolt holes, where the global model does not capture the severe stress and strain concentration. The very large stress concentration obtained from the submodel indicates that fracture may initiate at the edge of the bolt hole at a load much lower than the tensile capacity of the gusset plate connection.

Fig. 9(a) shows a photographic view of the fracture observed along the compression diagonal L9/U10 (fracture (A) in Fig. 3(b)). Fig. 9(b) shows the maximum principal stress field in the gusset plate, near the same perimeter rivet holes, evaluated at completion of analysis Step 4. On the left edge of the perimeter rivet holes, the maximum principal stress acts in the vertical direction. The direction agrees well with the fracture seen in Fig. 9(a), and indicated by dotted lines in Fig. 9(b). Therefore, it is suspected that fracture initiated on the left edge of the holes (as viewed in Fig. 9) due to large normal stresses, and propagated straight until the fracture grew large enough to disturb the stress field and change the direction of fracture propagation. The comparison in Fig. 9 indicates that the nonlinear analysis procedure and detailed local model may provide important insight of the gusset plate failure. In this study, the initiation of fracture is not quantified. The critical stress and strain values depend substantially on the meshing scheme, as demonstrated in Fig. 6.

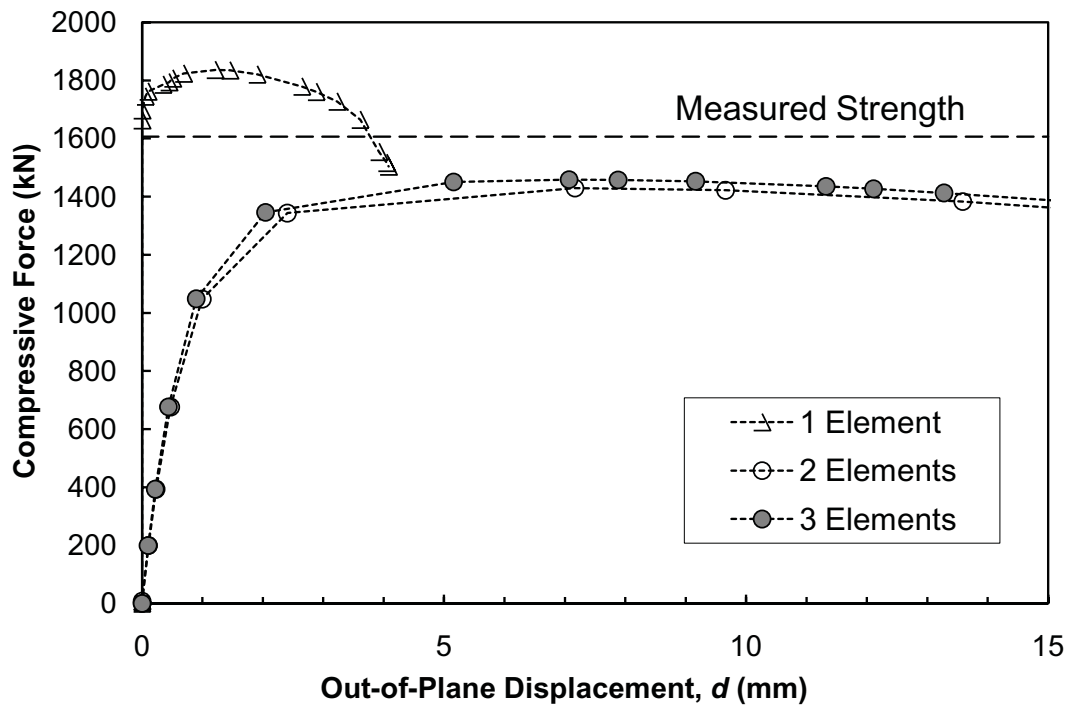
three models. The meshing scheme validated from the first study was used, while the number of elements across the thickness of the gusset plate was varied between one and three. The out-of-plane displacement d indicated in Fig. 7(a) is plotted in the abscissa, and the total compressive force applied to the brace member is plotted in the ordinate. Fig. 7(b) indicates that the maximum strength and failure due to instability is represented well by using either two or three elements across the thickness of the gusset plate. Using either model, the measured strength of 1,606 kN was predicted within 10%, while the computed out-of-plane displacement was on the same order as that measured during the test (reported as 25 mm).

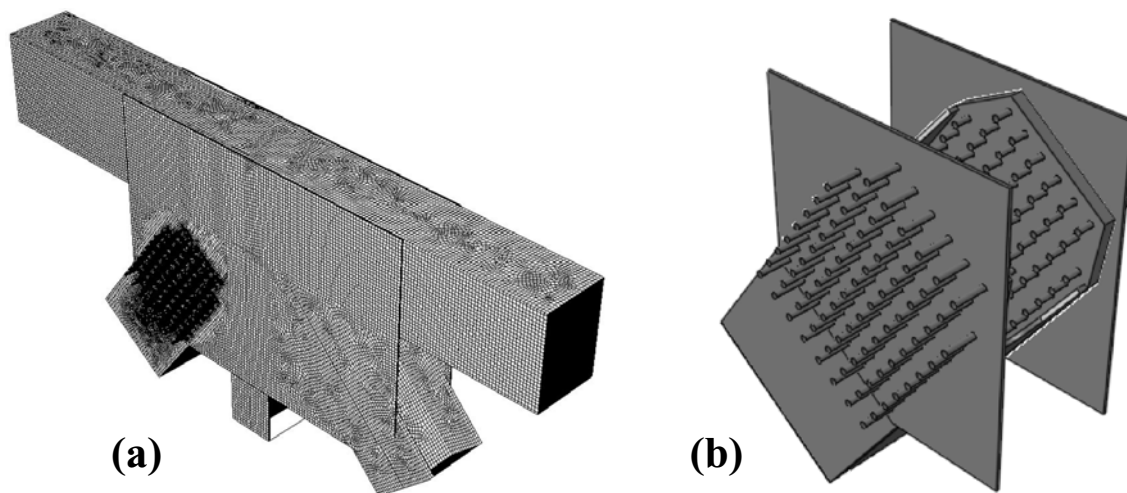
The truss forces obtained from the bridge analysis supplied the loading conditions for the detailed, 3D finite element model shown in Fig. 8(a). The concept of the loading condition is shown in Fig. 2(b). The model consisted of five short, stub segments connected through a pair of gusset plates. The dimensions of each component were taken from the original construction drawings (Mn/DOT 2008). A rigid shell plate was attached to the far end of each stub segment and to the top of the upper chords, at the location where the floor truss seated. The vertical load and truss forces were applied to the center of the shell plate, perpendicular to the plate. The truss loading points were allowed to translate only along the original member axis, and the top loading point was restrained from motion in the out-of-plane direction. The transverse reactions computed at the loading points were minimal.

- Fig. 8.** Gusset plate connection models: (a) panel point U10; and (b) compression connection.
- Fig. 9.** Fracture along L9/U10: (a) observed fracture; and (b) distribution of maximum principal stress.

Fig. 12 compares the response obtained from the two connection models, the U10 connection shown in Fig. 8(a) and the compression connection shown in Fig. 8(b). The response is represented by the compression in L9/U10, incremented according to Steps 1 to 4, against the

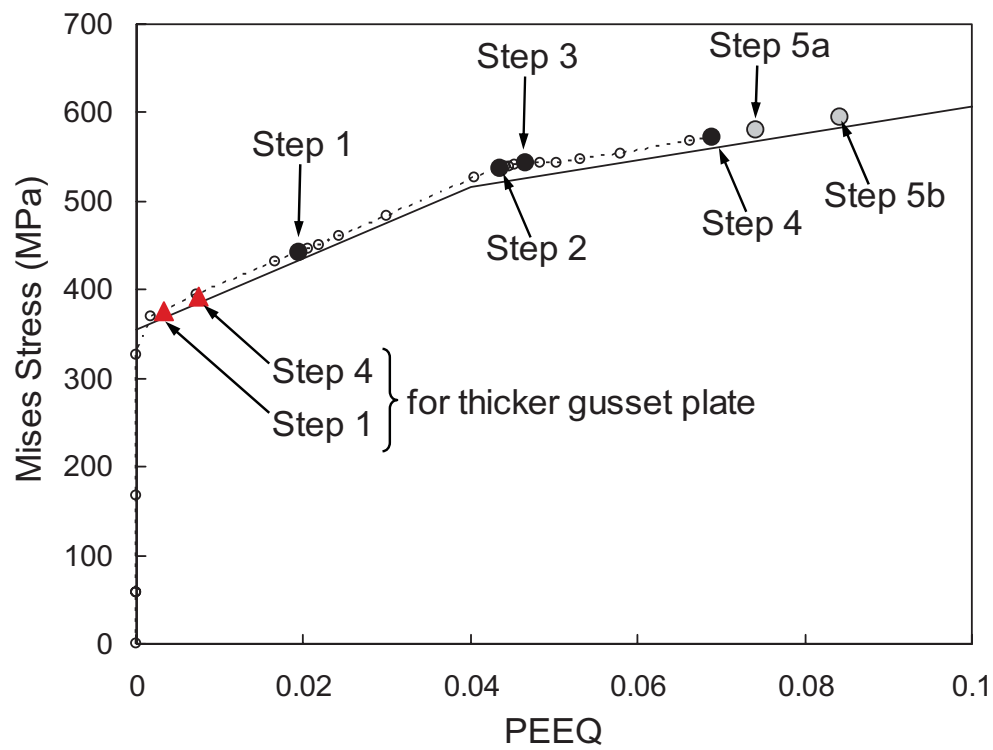
Fig. 11 plots the Mises stress versus equivalent plastic strain (PEEQ) measured at a sampling point (dashed line). As indicated in Fig. 10, the sampling point is adjacent to an upper-left rivet hole, and was identified as a critical point where large compressive stresses develop. For uniaxial loading cases, the relationship between Mises stress and PEEQ coincides with the true stress versus logarithmic plastic strain material model (solid line). Therefore, Fig. 11 is also a confirmation that the computed stress and strain field agrees with the assumed material plasticity model (piecewise-linear line in the figure). At the end of Step 1, the sample point is already yielded. At the end of Step 4, the Mises stress was as high as 552 MPa and the PEEQ was 0.07. The PEEQ was increased by 0.02 between Steps 1 and 2, and between Steps 3 and 4. In other words, loads DL2 and CL produced substantial plastic strains in the gusset plate. The increase in stress and PEEQ caused by temperature gradient was greater than the increase from live loads (LL) but less substantial than that due to the construction loads (CL). The PEEQ produced by the sum of all loading effects was roughly 0.08.

Fig. 11 also shows data (triangles) obtained from analysis with ABAQUS after increasing the gusset plate thickness from 13 mm to 25 mm, the latter which would satisfy current design requirements. Although the thicker gusset plate also yielded at the end of Step 1, the PEEQ at the sampling point at the end of Step 4 was smaller than 0.01. Very limited yielding was observed in the thicker gusset plates, except in a very limited region including the sampling point. Such limited yielding is accepted in steel connection design. Therefore, the thicker gusset plates would have sustained the same load conditions without discernable yielding.

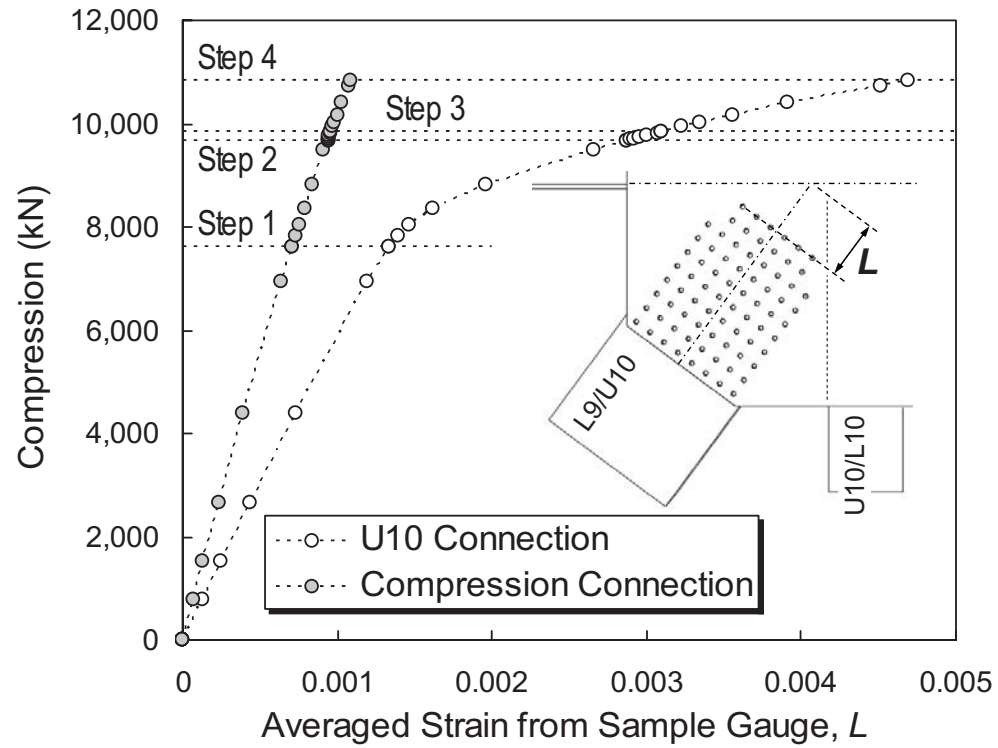
Fig. 12

averaged strain of gauge length L indicated in the figure. The elastic stiffness was 40% smaller for the U10 connection compared to the compression connection. Although the U10 connection softened progressively as the compression exceeded 7,500 kN, the compression connection remained largely elastic when the analysis was terminated at a compression of 11,120 kN. The U10 connection was affected substantially by yielding in the region in front of the connection. Figures 10 and 12 suggest that, beyond Step 1, the stress was redistributed from the front of the connection to the shear lines along the perimeter rivet holes, resulting in the wide yielded region surrounding member L9/U10. Discernable yielding did not occur in the compression connection at the end of Step 4.

Standard design procedures (Holt and Hartmann 2008; Kulicki et al. 2006) check the compressive strength and shear strength independently, but do not check the interaction between the forces. On the other hand, results from this study suggest that shear-compression interaction contributed to the substantial yielding of the gusset plates, and therefore, may have played a key role in the I-35W Bridge collapse.
